TRI-SERVICE CONFERENCE ON CORROSION

21-23 JUNE 1994

Effectiveness of Thin Film Fluoropolymers as Protective Coatings in Marine Environments

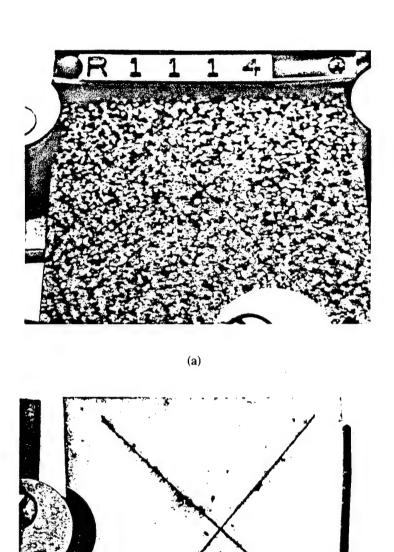
All coated HY-80 steel panels experience. slight to extensive rust through and complete loss of coating adhesion on a few panels. The fluoropolymer coating (6108) provided protection that was equal to 6255 (solid-film) and was superior to the 6256 (solid-film) coating. A comparison between 6255 and 6256, each containing an intentional defect, is shown in Fig. 1. The 6256 coating had completely failed with uniform rust through and sizeable amounts of coating loss. Conversely, the 6255 and 6108 (not shown) panels exhibited moderate rusting in the "x" scribe and a few isolated rust through spots in areas away from the defect. A large number of small blisters were located adjacent to the "x" scribe on the 6255 panel but were not observed for 6108. 6256 panels without an initial defect experienced uniform failure and rust through, whereas only a few pin-head size rust spots were found on the 6108 and 6255 coated panels without intentional defects.

Fig. 1. Photographs of HY-80 Panels Coated with (a) 6255 and (b) 6256 after Two Years Exposure to a Marine Atmosphere.

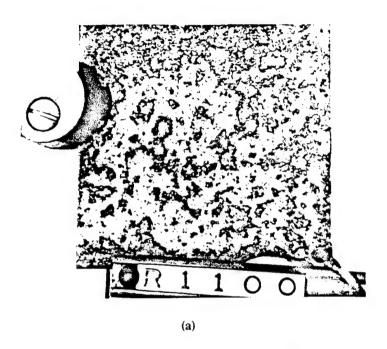
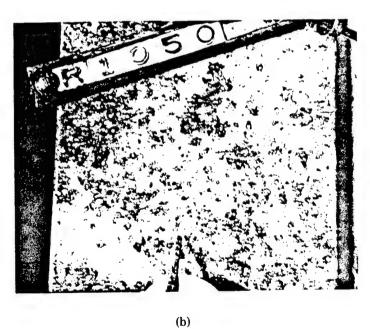
All coated AISI 304 panels experienced severe discoloration of the coating (Fig. 2). The nature of this deterioration remains unclear; however, no underfilm corrosion or coating adhesion loss was observed. Because of the nearly identical appearance of all coated stainless steel panels, it was impossible to rank the inclividual coatings in terms of performance.

The coated stainless panels exposed to the periodic seawater environment behaved identically to those specimens exposed only to the marine atmospheric environment (Fig. 2). This behavior was not exhibited by these same coatings on the HY-80 substrate, which suggests that the stainless steel substrate influenced the deterioration of the coatings. The nature of this interaction remains unclear at this time.

Fig. 2. Photographs of AISI 304 Panels Coated with (a) 6255 after Two Years Exposure to a Marine Atmosphere and (b) 6108 after Two Years in Marine Atmosphere with Periodic Seawater Wetdown.

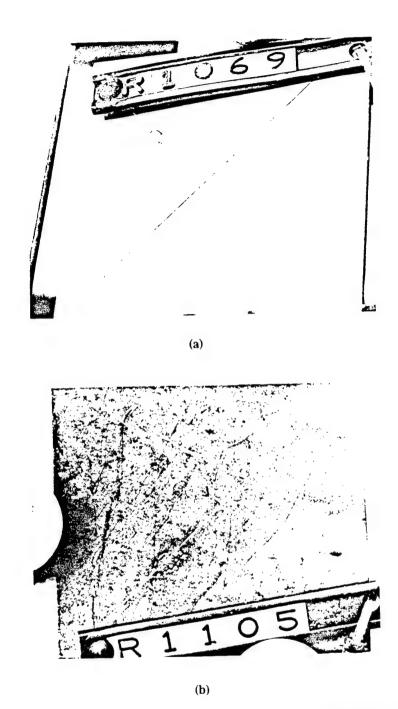
Both 6255 and STF coatings on AA6061-T6 panels held up well to the more aggressive seawater wetdown environment. The discolored spots on the 6255 coating were in greater number and larger in size compared to those observed on panels exposed to the marine atmosphere only environment; however, the coating remained intact with no apparent loss of adhesion. Attack of the bare metal in the "x" scribe was more extensive for these panels compared to those exposed only to the marine atmosphere (Fig. 3). The STF coated panels also performed well however localized, white corrosion spots about the size of a pinhead were present on all panels. As with the 6255 coating no loss of adhesion was observed (Fig. 3).

Fig. 3. Photographs of AA6061-T6 Panels Coated with (a) 6255 and (b) STF after Two Years in a Marine Atmosphere with Periodic Seawater Wetdown.

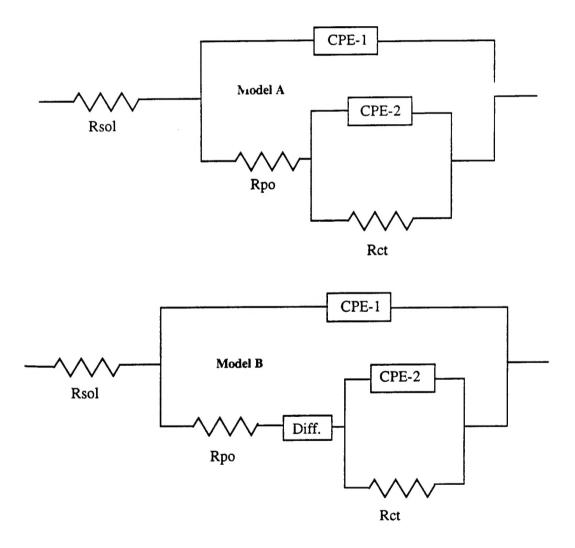
The impedance data was analyzed using a CNLS program. The electrical analogs are shown in Fig. 4. The impedance behavior of coated HY-80 specimens was best represented by Model A; whereas, Model B typically applied to both AA6061-T6 and AISI 304 coated specimens. The two models are similar except Model B contains a constant phase element in series with the coating pore resistance ($R_{\rm po}$) which is associated with diffusion within coating pores. This diffusional impedance manifests itself as a broadening of the phase angle minimum in the Bode-angle plot at intermediate frequencies (ca. 100 Hz). Examples of the CNLS fit for each substrate type are shown in Figs. 5-7.

Fig. 4. Equivalent Circuit Models for (a) Coated HY-80 Steel and (b) Coated AA606-T6 and AISI 30-. Rsol is the Solution Resistance, Rpo the Coating Pore Resistance, CPE-1 a Constant Phase Element that Represents the Coating Capacitance, Rct the Charge Transfer Resistance at the Coating/Metal Interface CPE-2 a Constant Phase Element that Represents the Capacitance at the Coating/Metal Interface and Diff. is aDiffusion Element (CPE-3).

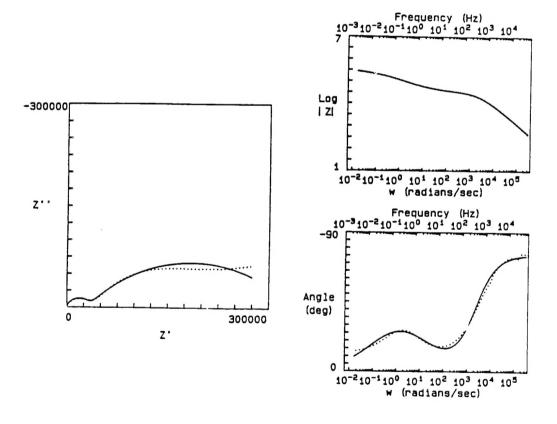
Fig. 5. Impedance plots for 6108 coated HY-80 steel immersed in aerated seawater for 120 days. Dotted lines represent experimental data and solid lines the CNLS fit (Model A).

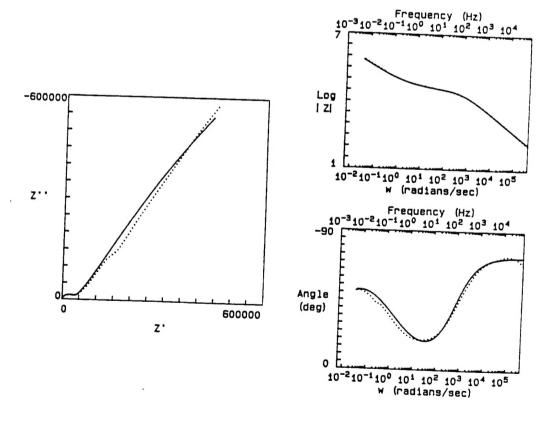
Fig. 6. Impedance plots for 6108 coated AISI 304 stainless steel immersed in aerated seawater for 53 days. Dotted lines represent experimental data and solid lines the CNLS fit (Model B).

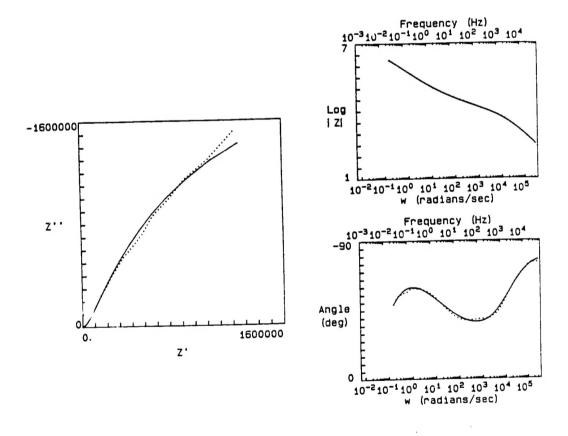
Fig. 7. Impedance plots for STF coated AA6061-T6 immersed in aerated seawater for 116 days. Dotted lines represent experimental data and solid lines the CNLS fit (Model B).
